Blower Motor Replacement_____

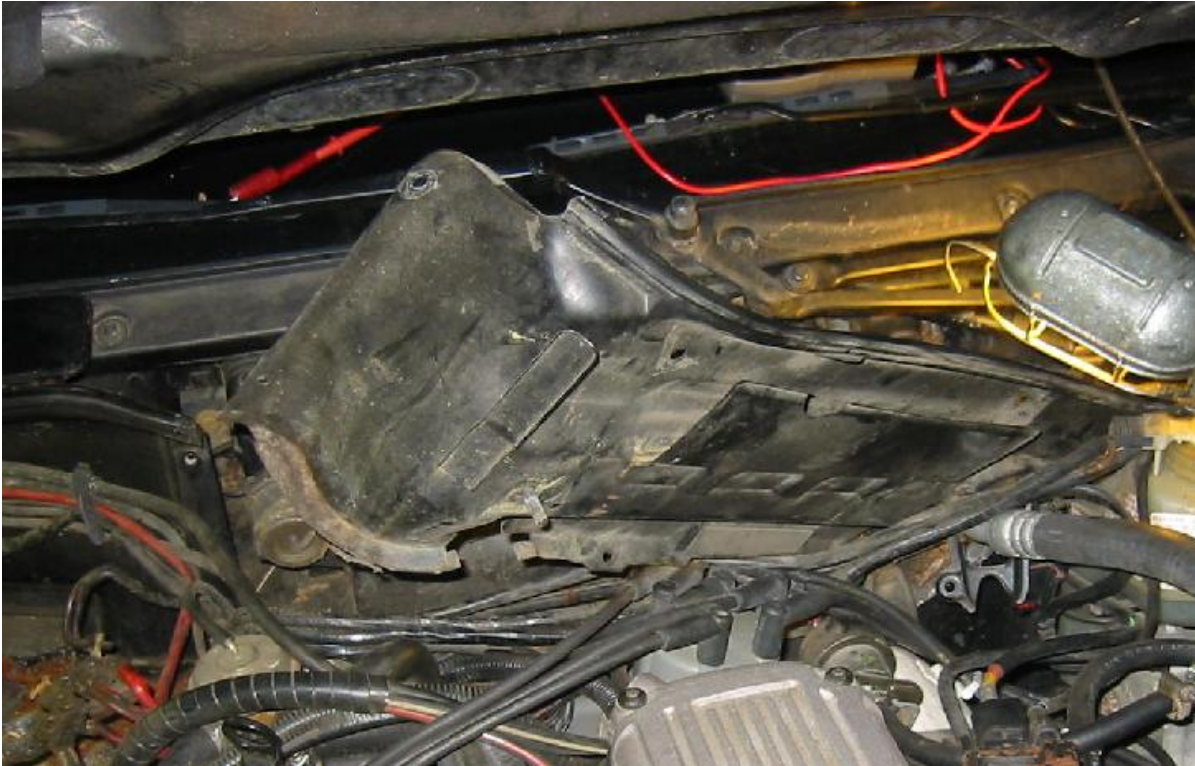
This shot shows the false firewall unbolted from the body and pivoted up from the evaporator case.

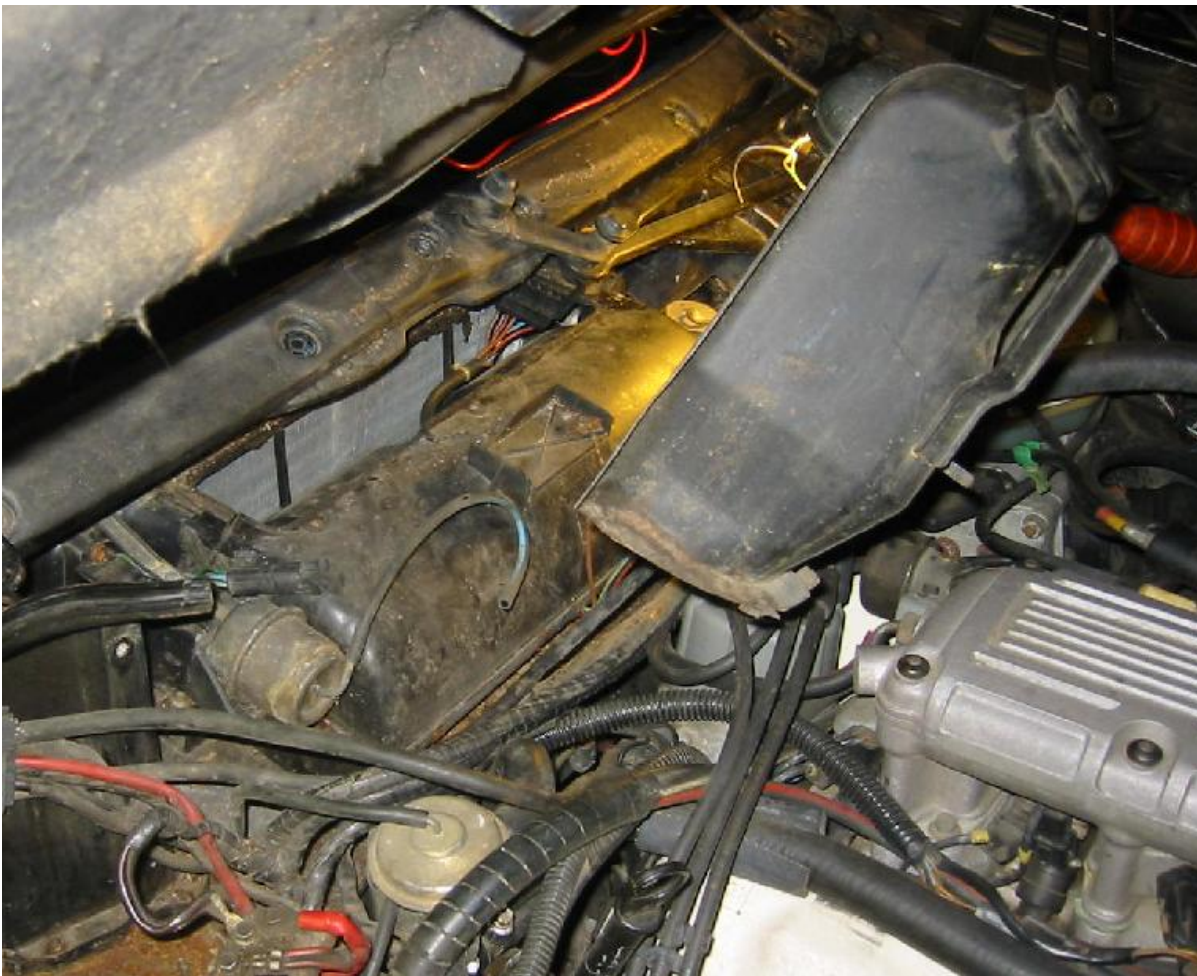
(below) Looking at the case.

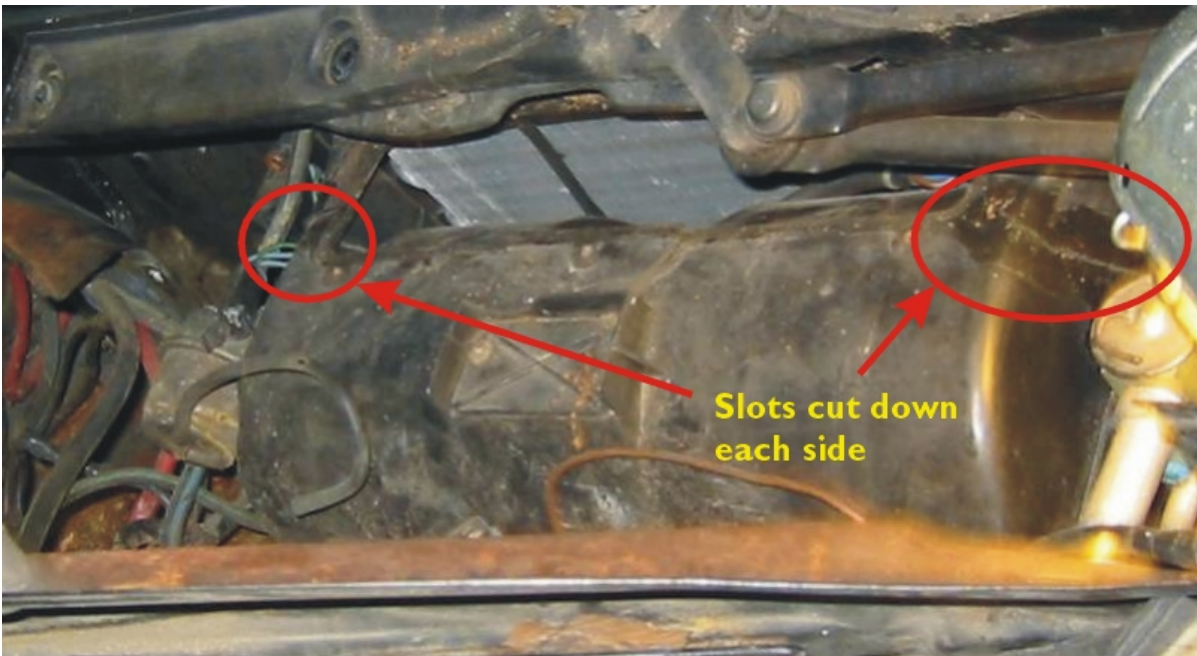
This shows the cuts to be made in the case. The plastic is rather flimsy. After cutting, there are several clips holding the top and bottom halves together that need to be removed.

I resealed the cuts with a urethane bead weatherstrip, because it's incredibly sticky but not permanent. Silicone sealer, tape, and most other caulks won't stick to the case.

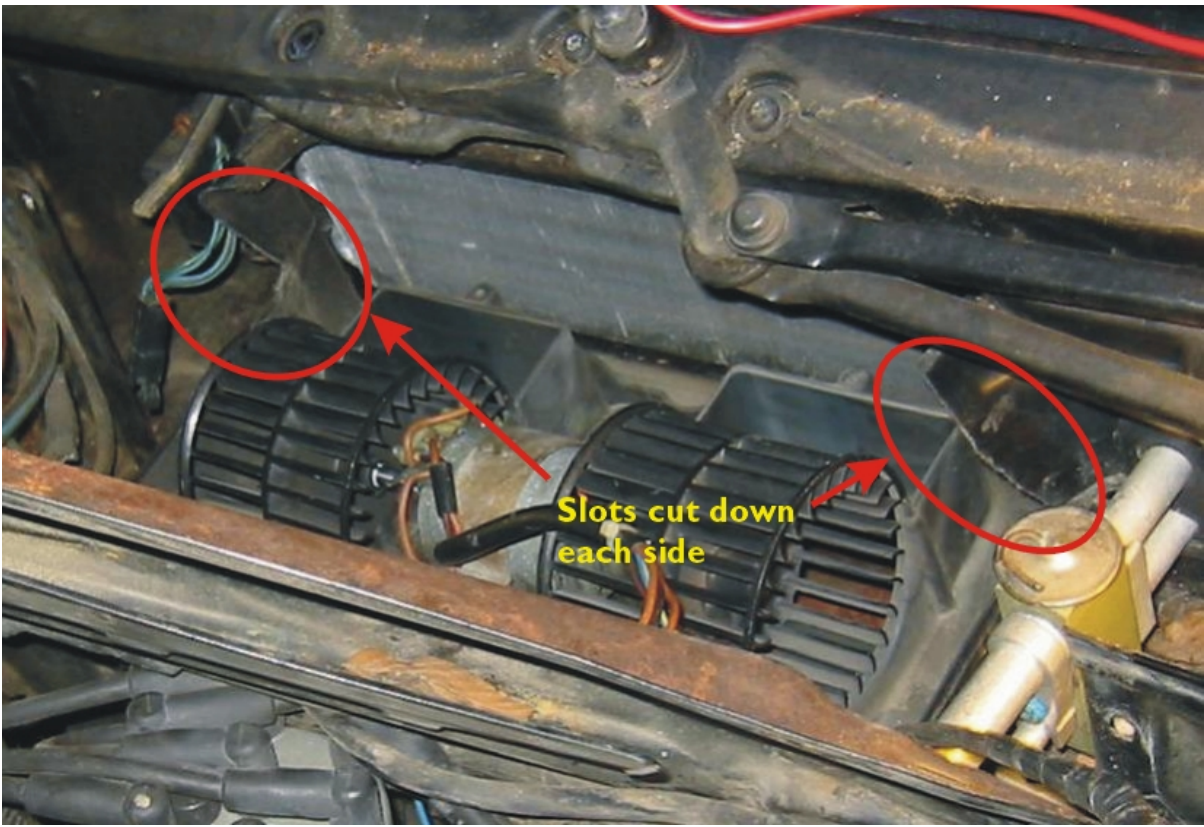
This shows the lower part of the case with the front half of the cover removed. Notice the two vertical support pieces are cut at the back half.

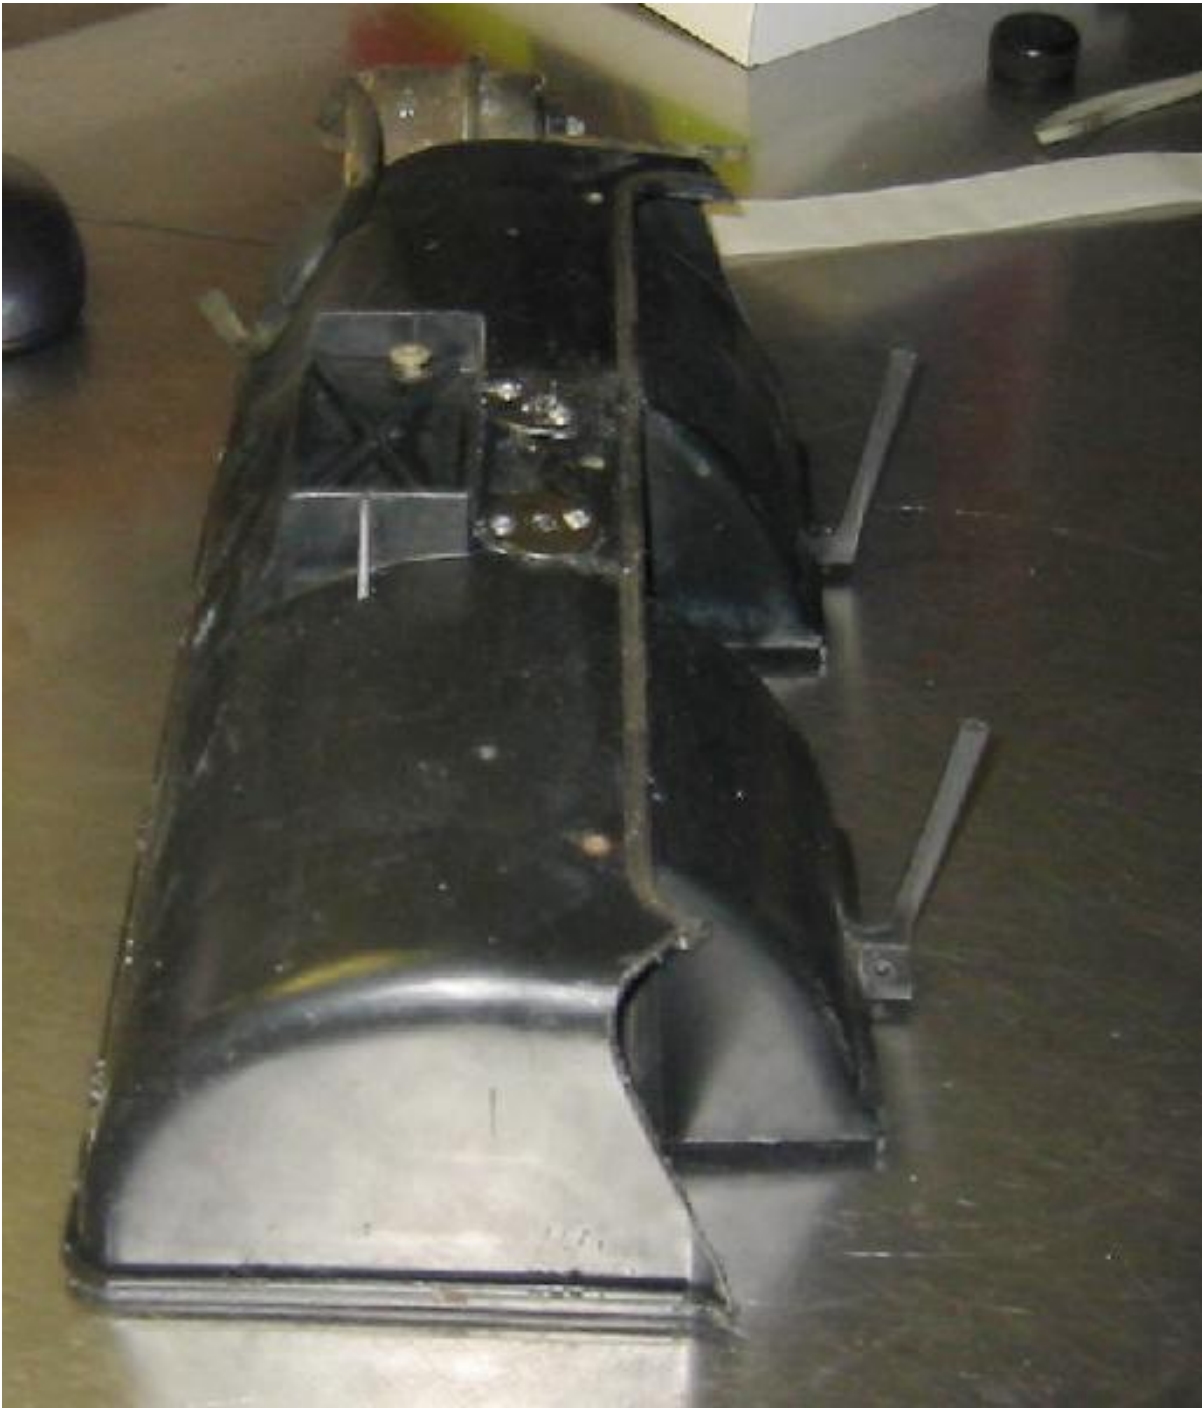
This shows the case with those plastic supports.
