# Rebuilding The Ford 4.0L Pushrod V6

The original 2.6L engine was replaced by the 2.8L, which was upgraded to the 2.9L and then finally bored and stroked to make it into the 4.0L that was used in the Rangers, Aerostars and Explorers starting in 1990. It was replaced by a SOHC engine from this same family at the end of model year 2000.

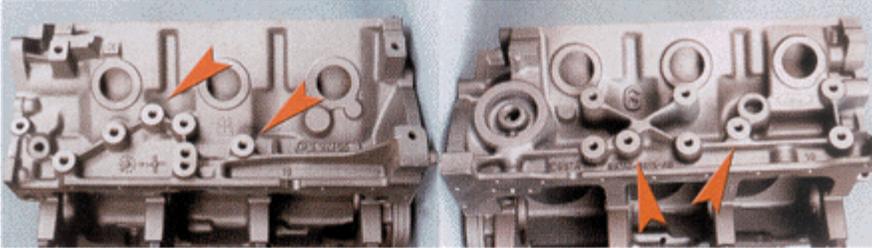
The block was redesigned again in '97 to reduce noise, vibration and harshness (NVH). Both of the pan rails on the 97TM-AA casting were wider and there were two more gussets added between the pan rail and the horizontal rib that's right above it on the passenger side. The dipstick hole on this block was enlarged to about 0.435", too.
